Sustainable Restoration of Yale University's Art + Architecture Building

RUSSELL M. SANDERS, BENJAMIN SHEPHERD, ELIZABETH SKOWRONEK, AND ALISON HOFFMANN

Renovation of Paul Rudolph Hall at Yale University

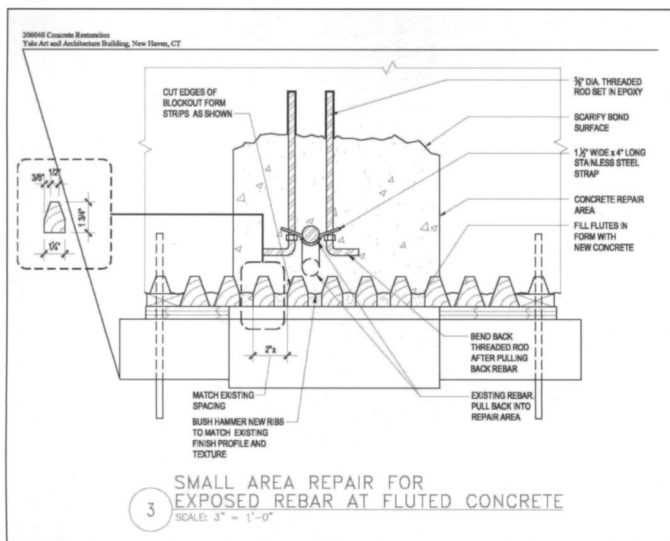
Fig. 2. Schematic of the corduroy-concrete repair detail, showing custom wood formwork, Paul Rudolph Hall. Courtesy of Hoffmann Architects, Inc.

Like the board-form spandrel beams, the distinctive “corduroy”-textured concrete suffered from poor construction practices. Shallow placement of steel reinforcement, with an inch or less of concrete protection in many areas,⁸ had led to corrosion, cracks, and spalls. Restoration involved removal of the delaminating concrete, repair and treatment of embedded steel, and re-covering of the steel reinforcement to an appropriate depth with color- and texture-matched concrete. Approximately 500 square feet of fluted concrete throughout the structure was restored using this repair strategy.

Because the corrugated vertical ribs were not uniform in dimension, custom formwork had to be created for each area of repair (Figs. 2 and 3). Here again, developing and testing a concrete mix that would replicate the original appearance, hold up well as a thin overlay, and resolve the problems of the existing construction was the challenge. Concrete was placed by hand into the fluted forms, with individual pieces of aggregate forced between block-outs into the mix. To properly consolidate the material, the concrete-restoration

contractors used a needle-type vibrator along the formwork, then tapped the outside of the form with a mallet to minimize surface bubbles. Bush hammering of finished repair areas reproduced the fluted concrete's distinctive rough surface texture.

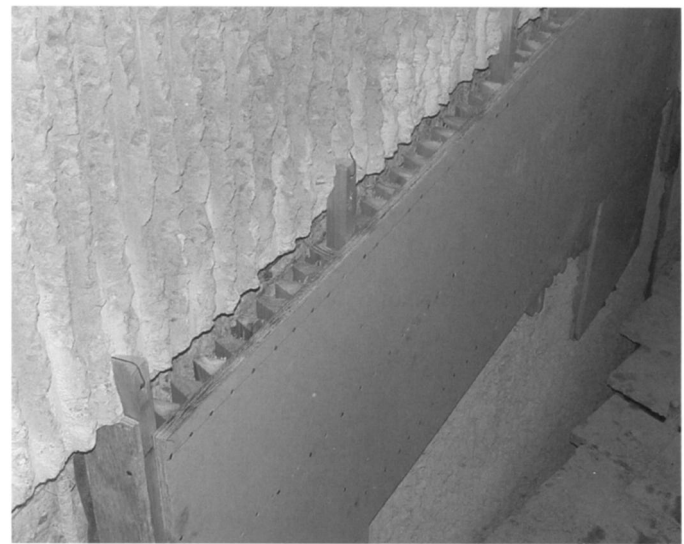
Fig. 3. Wood formwork in position for corduroy-concrete repair, Paul Rudolph Hall, photograph 2008. Courtesy of Hoffmann Architects, Inc.

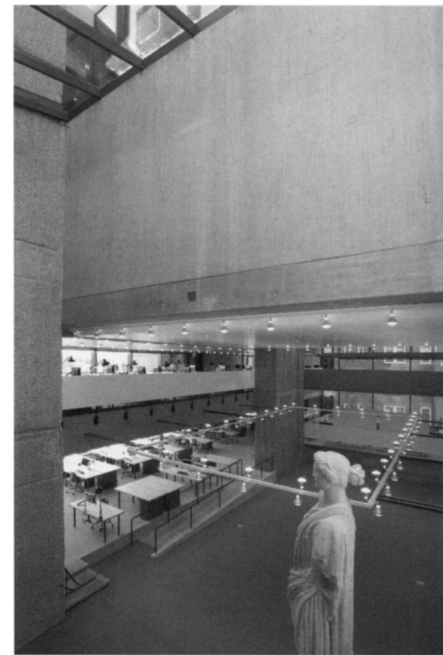
Fig. 4. View of fourth-floor jury space and fifth-floor studio space, including the statue of Minerva, Paul Rudolph Hall. Photograph by Richard Barnes.

Past renovations had severely altered the building's once-soaring spaces, slicing the double-height drafting room into separate levels and creating uncomfortable, dim rooms. To re-create the original balance of light and shadow, as well as volume and void, the project team removed the mezzanines that had been inserted after 1969 and divided the space. Most notably, the drafting room at the building's core was restored with the removal of the mezzanines, which allowed daylight into the space. A replica of the original statue of Roman

goddess Minerva was restored to her post overlooking the great hall (Fig. 4).

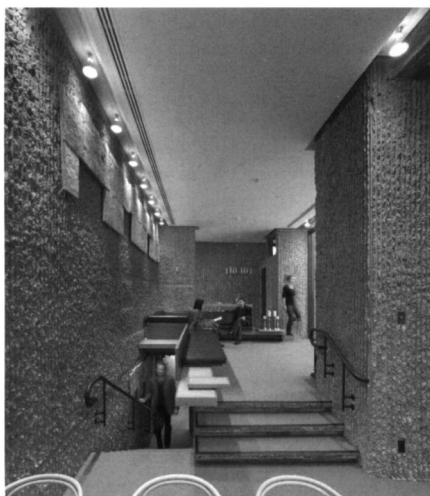
Fig. 5. Custom lighting in the restored penthouse, Paul Rudolph Hall, photograph 2008. Photograph by Peter Aaron, courtesy of Peter Aaron/Esto.

Special attention was paid to interior lighting. Using Ezra Stoller's period photographs, the architects modeled both new and existing spaces to understand lighting quality. Custom fixtures with metal halide lamps replicated the appearance of the original incandescent lights, but they consume only 39 watts, rather than 150 (Fig. 5). Aluminum reflective paint, vernal lenses, and prismatic lamps result in a scattered-light effect that reproduces Rudolph's design intent, with vastly improved energy performance.

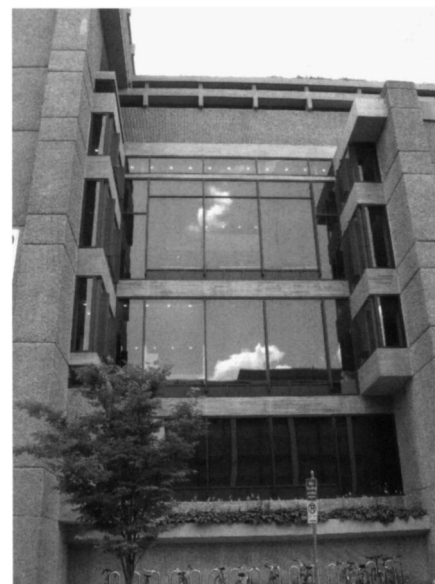
Fig. 6. Installation of new insulating glazing at the east facade, Paul Rudolph Hall, photograph 2008. Courtesy of Hoffmann Architects, Inc.

Building-envelope performance. Improving building-envelope thermal performance is the most basic way to increase the energy efficiency of virtually any building, and this project was no exception. The building's continuous southwestern exposure, along with the unfortunate window replacement of the 1990s, left interior spaces, many of them faculty offices, prone to overheating. New double-glazed windows insulate against heat transfer, while a spectrally selective low-e coating admits daylight with an appropriate level of solar control. Not only does the improved glazing dramatically reduce summer cooling loads and retain interior heat during the winter; it reduces electric-lighting costs and restores occupants' connections to the outdoors.¹⁷ With unobstructed, sweeping views and meticulously detailed anchorage and framing, the redesigned glazing was designed to optimize performance with respect to insulation, moisture, and daylight (Fig. 6).

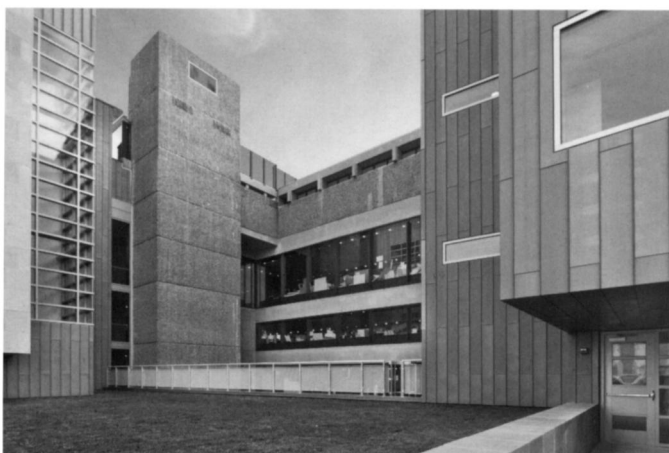
Fig. 7. Fourth-floor terrace and green roof, Paul Rudolph Hall, photograph 2008. Photograph by Peter Aaron, courtesy of Peter Aaron/Esto.

Roofs also suffered the effects of time, weather, student abuse, and failed repairs. Leaks had become pervasive. To restore roof terraces as usable outdoor areas, reflective pavers⁹ were installed over a modified bitumen roof (MBR) membrane assembly, with new planters

and seating throughout. Period photographs show that the original terrace pavers, which were not in place at the time of the 2008 renovation, followed a running-bond pattern, and the new pavers were installed to reproduce this configuration. Roof areas not open to public traffic have cold-adhesive MBR assemblies with white granular cap sheets to reduce heat absorption.¹⁰ As multilayer systems, MBR membranes resist puncture and provide waterproofing redundancy; bituminous compounds also offer flexibility and self-healing properties,¹¹ qualities critical to durability and, consequently, sustainability of the roof assembly.

At the roof level, installation of tapered polyisocyanurate board insulation and rigid extruded-polystyrene insulation at terraces improved energy performance by preventing heat loss through the roof. Fully abutted, parallel courses with staggered joints were specified to minimize heat transfer between boards. Existing roofing was replaced with roofing with a high solar reflectance index (SRI), which incorporates reflective granules into white cap sheets. By reflecting much of the sun's UV radiation, the light-colored roofs keep both the building and the surrounding area significantly cooler. The Art +

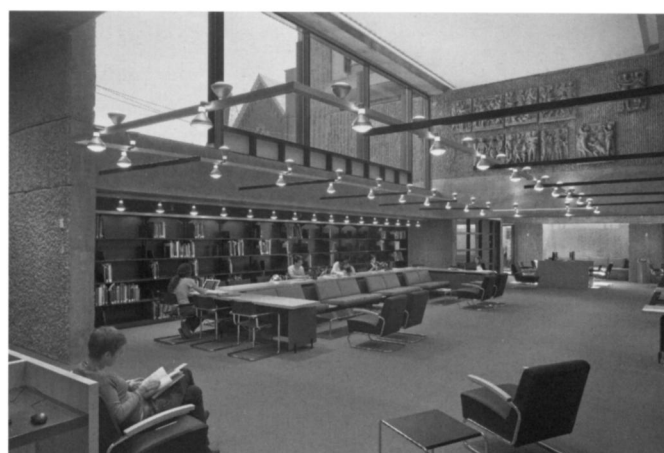
Fig. 8. Robert B. Haas Family Arts Library, Paul Rudolph Hall addition, photograph 2008. Photograph by Peter Aaron, courtesy of Peter Aaron/Esto.

Former students of Rudolph, Yale School of Architecture Dean Robert A. M. Stern and project design principal Charles Gwathmey were committed to applying their mentor's aesthetic to the renewal of his seminal work (Fig. 8). However, the timeline for achieving this goal was extremely short. Yale did not intend to displace the School of Architecture for more than one academic year, which meant that once classes ended in May 2007, the team had less than 15 months to complete the project. Nevertheless, the project was completed on time, within budget, and to exacting quality standards. To honor its famed designer, the university rededicated the building as Paul Rudolph Hall.
